EFFICIENT FIELD INSPECTION AND EVALUATION FOR CONCRETE BRIDGE DECK WITH ASPHALT OVERLAY

Structure Research Team

Korea Expressway & Transportation Research Institute

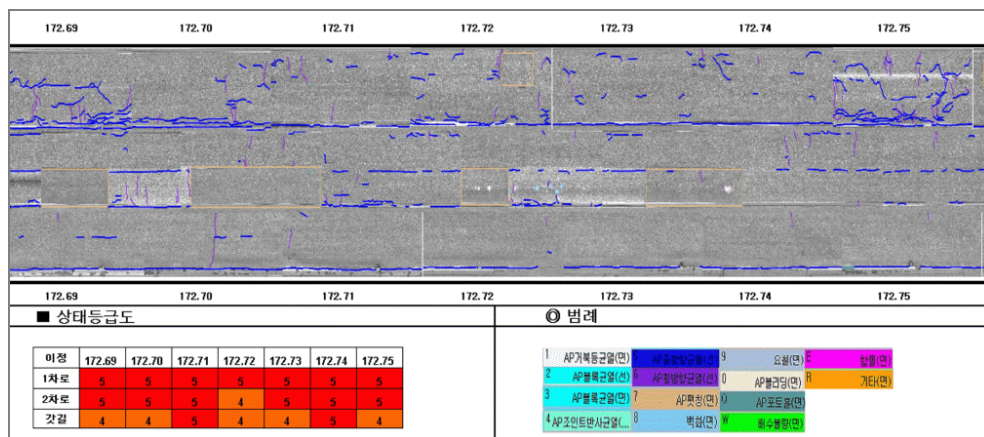
Figure 4 An inspection example achieved by the road inspection system

Currently, visual inspections are regularly being done on deck surfaces as preventative maintenance. In the past, deck surfaces were visually inspected and their condition grades were determined by the judgment of the inspector. Pictures of road surface photographed by a road inspection vehicle system allowed the quantitative analysis for several damage types to evaluate deck surfaces. As a result, the bridge surface conditions can be graded according to the criteria in Table 1. Figure 4 shows an example evaluated by the system.

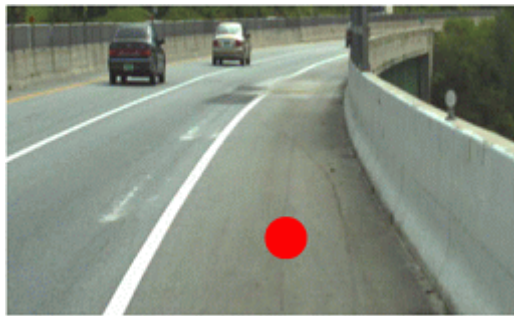
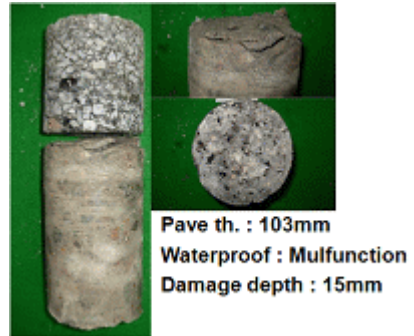
(c) C3

Figure 12 and 13 show inspection results of a bridge on Jungbu Expressway. Even though both locations of C1 and C2 had the good appearances, GPR system showed results corresponding to the deck truth data. The bridge deck under overlay was deteriorated at C2 but not at C1.
